PROPERTY INSPECTION REPORT

Prepared for: Mr. & Mrs. Home Buyer
Concerning: 1234 Apples St., Denton, TX 76210
By: Randall Wooten, Professional TREC # 8726
Date: 08/21/2005

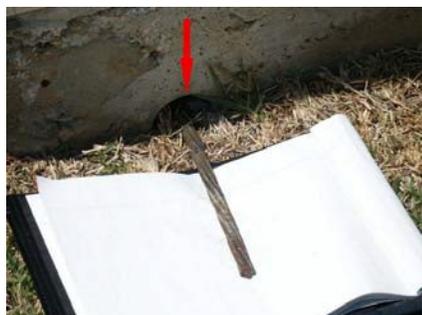
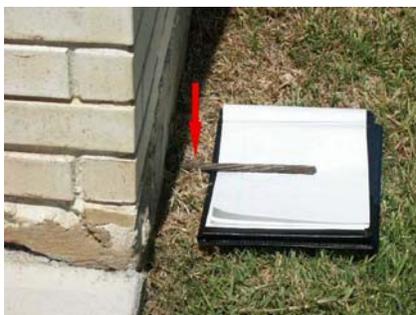
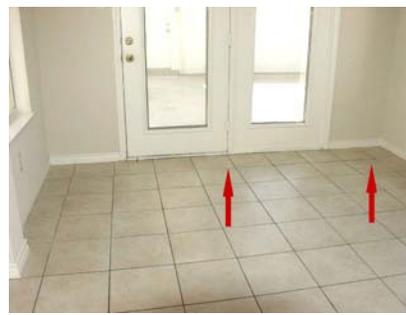
The foundation show signs of movement as noted below:

- (1) Observed exposed tension cables on back right side of house. Could not determine if cable had been tensioned.
- (2) Corner pops observed at back corners of home.
- (3) Observed heaving and depression areas in breakfast room of kitchen.
- (4) Observed new concrete patio at back of house. Visual observations for additional signs of movement were concealed.

The inspector is not a structural engineer. If any concern exists about the potential for future movement, the client should have a licensed engineer perform an evaluation of the foundation.

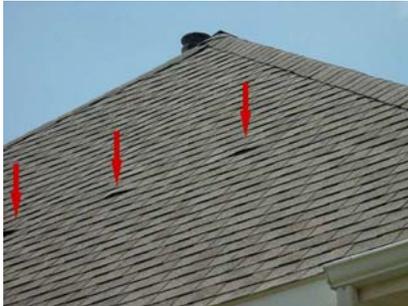
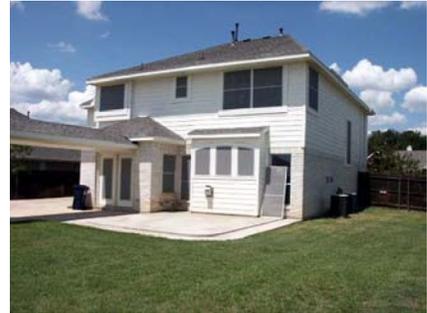
- (1) Observed one or more shingles on the left side of roof field that have lifted.
- (2) Observed a bulge in the roof field at the back of the home over the kitchen area.

It is recommended that the client have a licensed roofing specialist perform an evaluation of the roof covering.

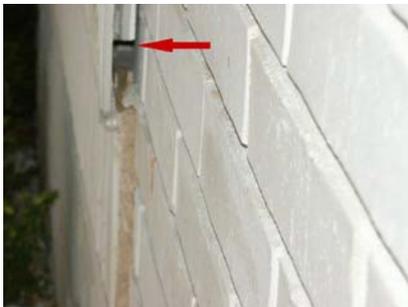
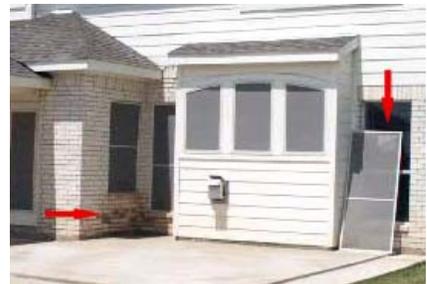
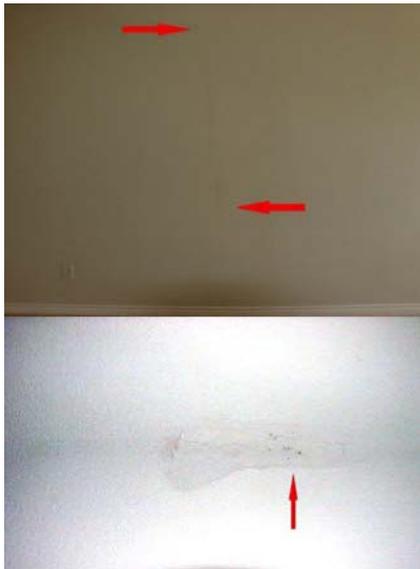
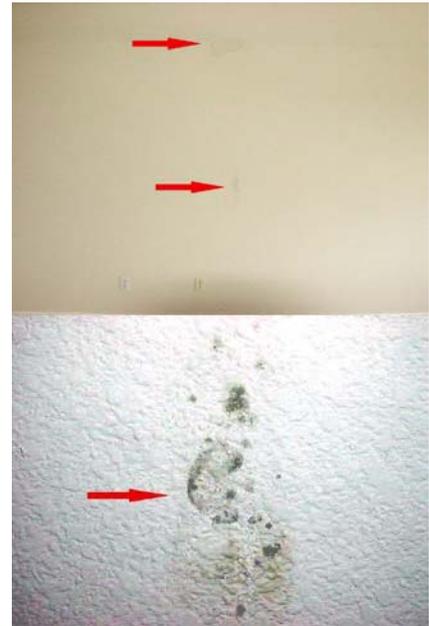
All interior walls have been freshly painted minimizing chances of observing any existing problems. Needs touch-up paint in family room on west wall next to kitchen entry.

- (1) Metal lentils over window and door openings are rusting.
- (2) Voids in mortar joints around kitchen window.
- (3) Caulking missing and/or deficient around multiple windows. Could allow wind driven rain to enter.
- (4) Observed signs of staining from water on bricks at the back of home (old/current problem?).

- (5) Observed organic growth and previous water stains on ceiling and left wall of master bedroom on first floor. Has been tried to be covered with paint. Possible roof leak still active.
- (6) Observed organic growth and previous water stains at one or more locations on left wall of family room on first floor.

The client should be a concern due to increased awareness of environmental issues associated with organic growths. It is recommended that the client should have a licensed mold inspector inspect the home.

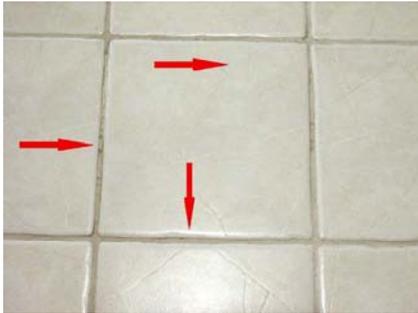
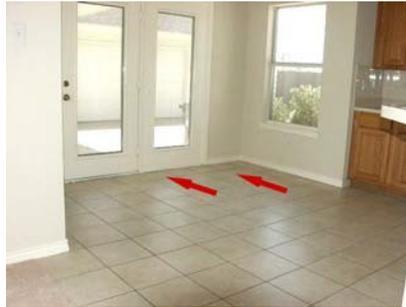
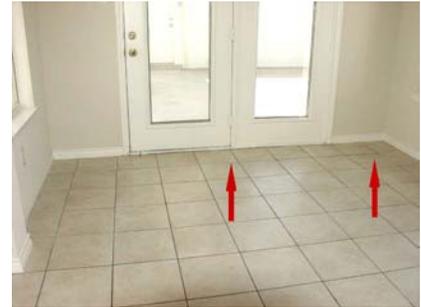
- (1) Observed nail-pops in one or more locations.
- (2) Observed loose/curled vinyl floor in master bathroom.
- (3) Observed missing grout in master bathroom tile.
- (4) Observed heaving and depression areas in breakfast room of kitchen.

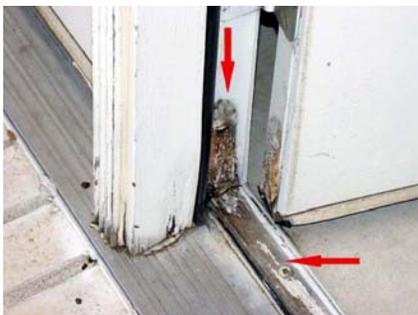
- (1) Observed rotten wood and water stains on double doors in kitchen breakfast area.

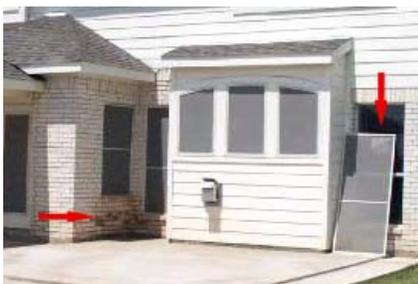
(1) Missing or damaged window screens at one or more locations.

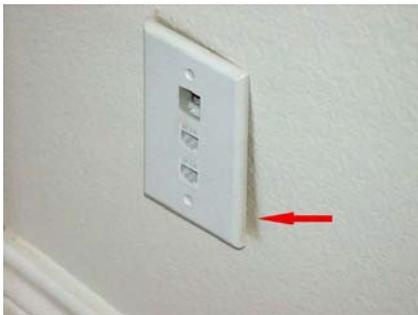
- (1) Found outlets to be loose and screws missing at one or more locations.
- (2) GFCI protected outlets missing labels in kitchen area.
- (3) All smoke alarms need to be re-installed with fresh batteries and tested.
- (4) No visible signs of GFCI protection on upstairs hydro-therapy bathtub.
- (5) No access to motor on hydro-therapy bathtub.

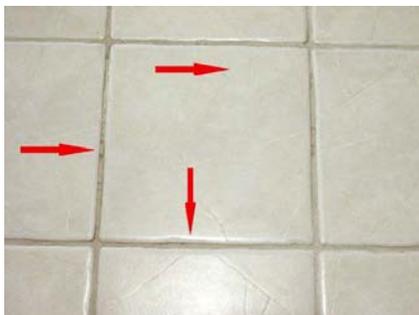
Observed missing grout in tile in master bathroom.
